## **FINALLY a CURE for the always leaking 4 speed tranny, not a Band-Aid, a REAL SOLUTION**

**Ray Duguay (saddlebagrail)**

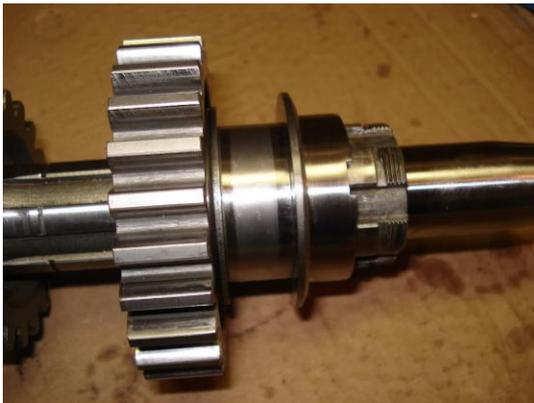
First...you can see an OEM spacer push on the fourth gear, there is a big seal running over it, that seal should not be the problem if properly lubricated.

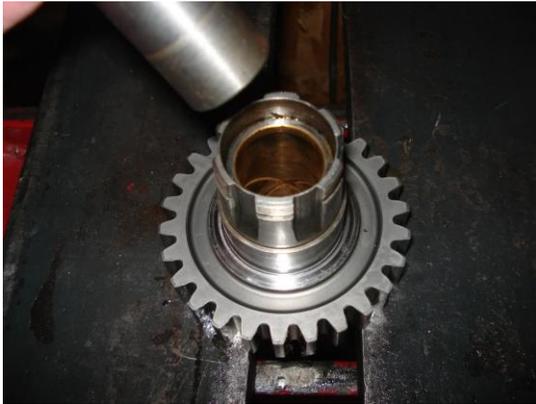
The first problem I have found is that the bushing is often too loose on the main shaft. So the first thing to do is press out the old bushing.

When the old bushing is out, I start by making a new one out of continuous cast bronze 660. Why making a new one? Often new bushings that came from different companies do not have enough material to clear everything, most of them, not to say all, are set at the factory to have minimal material to remove with a reamer, and often end up with many spots of material not removed.

If you look at the inside of your bushing after pressing it and the reaming is done, you will notice that it is not machined all around. So there is not enough material, meaning the bushing is not supporting on the shaft properly.... So it will likely wear unevenly. So what I do is make my own custom bushing with plenty of material left inside. Remember to clean, prime and put green Loctite inside the gear and on the outside of bushing before pressing.

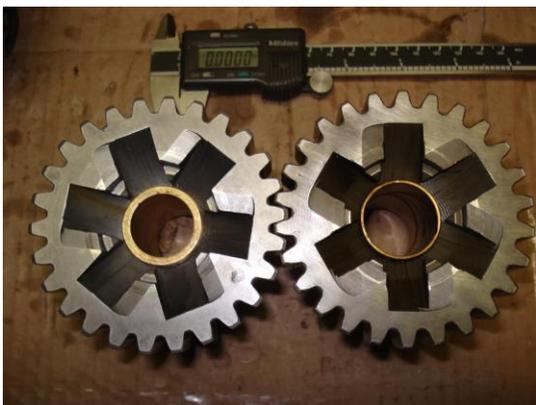
After the bushing is pressed in ... note the difference between both an old one and the newly press one I just made.

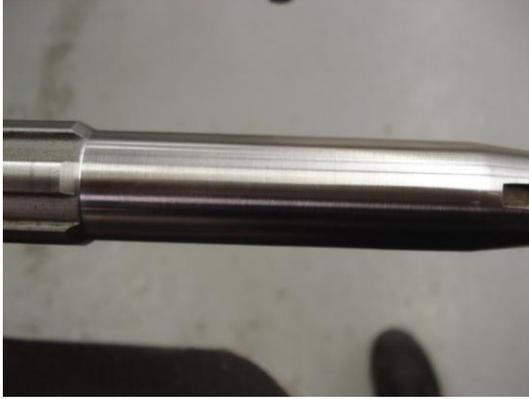
You will have to slightly polish the main shaft to get rid of small imperfection, or use a new shaft if it is too bad..., and then measure carefully so you could machine the bushing to achieve minimum clearance, in this case shaft measurement is .999 inch.

So I machined the bushing to .9997 inch, less than .001 inch of clearance (I am normally looking to have between .0007 to .0012 inch tolerances). You can only do it with a boring bar set up on the lathe; special reamer will only be able to machine one size, that's all.

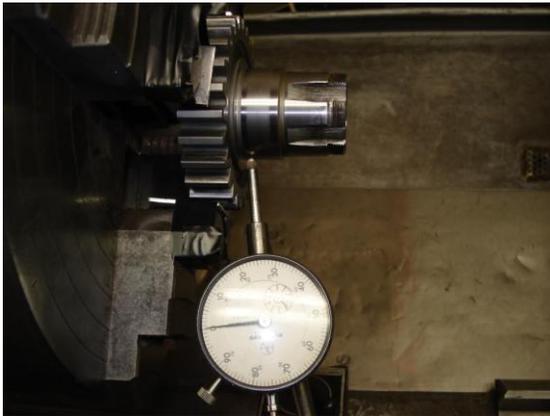
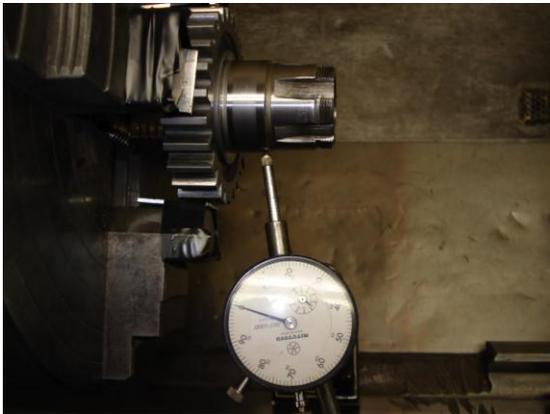
When everything is properly done, I set up the gear in the four jaws chuck and carefully dialing it to achieve a perfect run out, you have to be sure that where the bearing runs on, run perfect with a dial indicator.

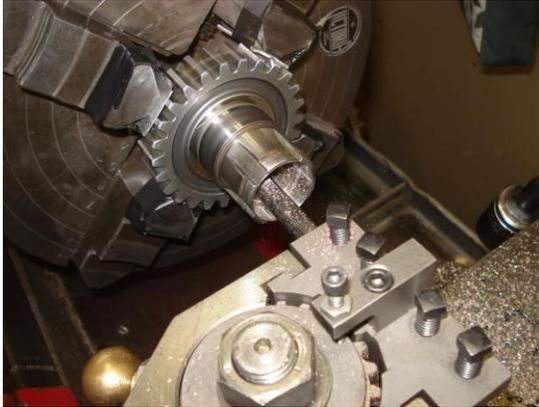
After you take care of accurately dialing the gear on the lathe, and you have the gear in perfect alignment, you could start the machining with a boring bar

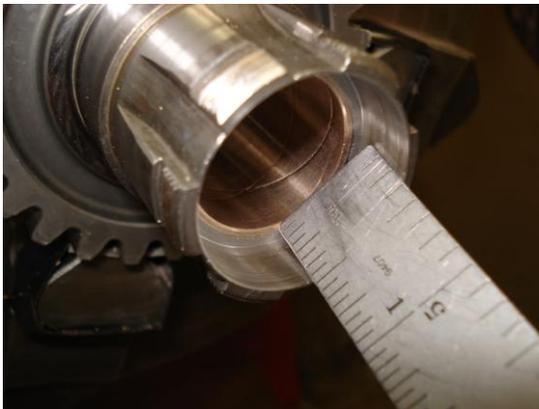
After the inside of the bushing is machined, I still continue modifying the end of the gear, here what I do, machining the recess a little bit deeper so I can put 2 seals in the end of the fourth gear instead of only one as OEM, the machining is done with either carbide or ceramic insert (much easier with a ceramic insert), the total depth required is 7/16 inch, instead of the 3/16 OEM, you can see the small oil groove inside the bushing not too deep but just enough to lubricate.

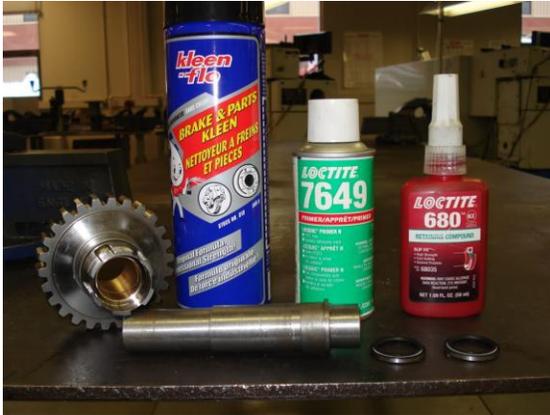
Ready to install the 2 new seals inside the end of the fourth gear: remember always clean /prime and put green Loctite on both the 2 small seals.

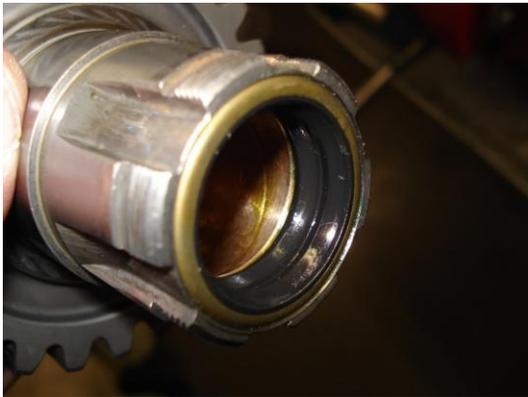
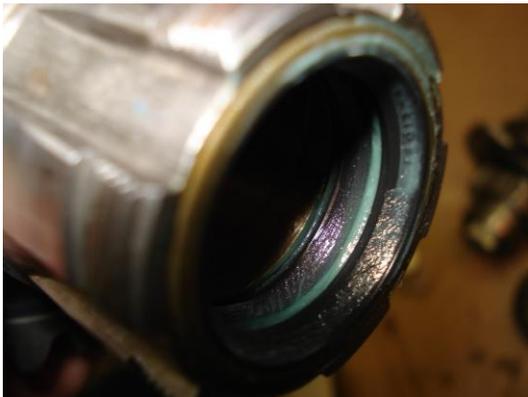
Since the outside seal will not receive too much oil, I simply put some Castrol synthetics grease between both seals, to make sure the seal outside get lubricate and cannot dry out.

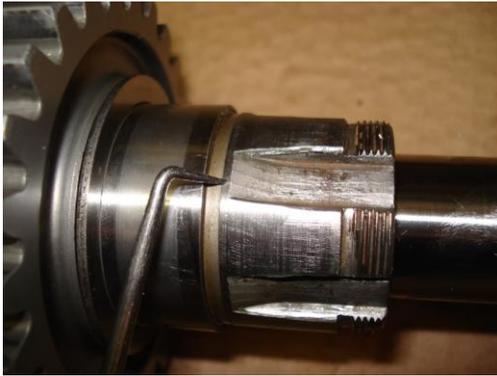
. When you are done with the gear, it is time to take care of the spacer, since the other main problem occur when some of the oil escape between the spacer and the shoulder of the gear, I always make a new type of spacer out of C1144 steel, with o ring groove inside so there is no way oil could escape.

Picture show you where the o ring in the spacer is located on the gear.

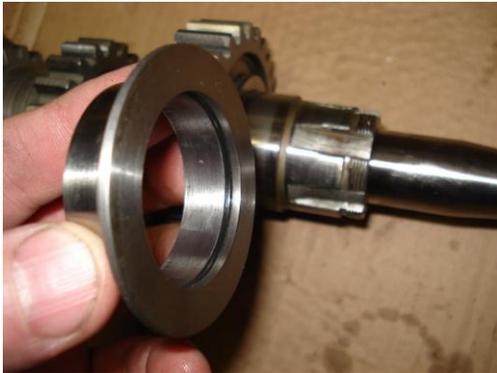
And the picture of the new spacer to accommodate the old gear.

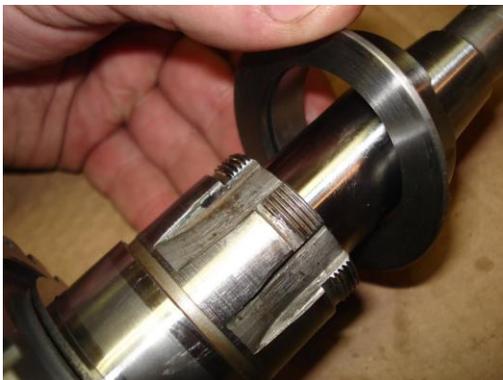
You could see the spacer with the o ring inside ready to be slip on the OEM gear, just put very small amount of grease around the o-ring to avoid scraping it.

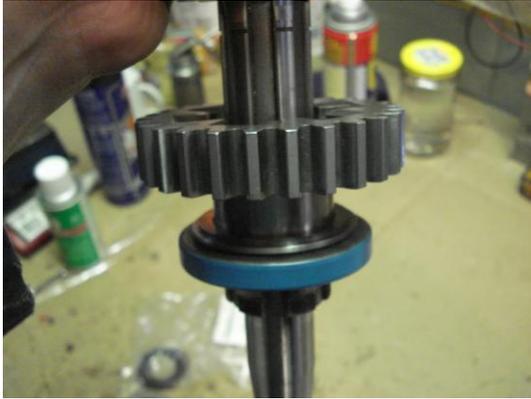
When everything is reassemble you will notice that there is now two seals at the end of the fourth gears including machining from all around the bushing with close tolerance and a 100% mating between both parts,100% mating between both parts means it will now take more time to wear out ,if properly lubricate ,... you will also end up with an O ring in the spacer ....so no more silicone from the outside around the spline.

See gear mounted vertically with nothing more than friction of the 2 seals and close tolerance getting the gear quite tight on the shaft, but still turn freely on the shaft no problems.

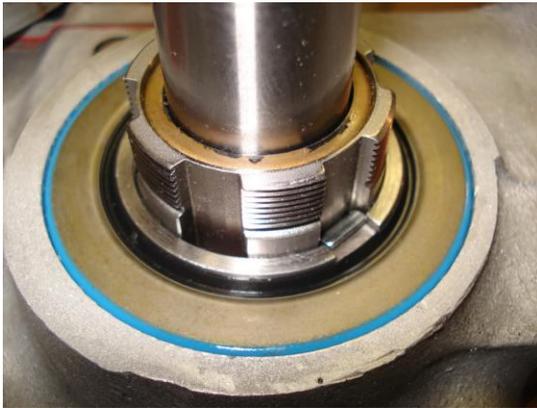
Here is the finished job with everything installed and ready to put the sprocket on. You could not see anything different from the outside, but this will definitely solve your leaking problem.

Note: I had tried a tranny with oil inside without the sprocket at the end, and there was no leak after at least 2 months on the floor, hard to believe but proves this modification is working.

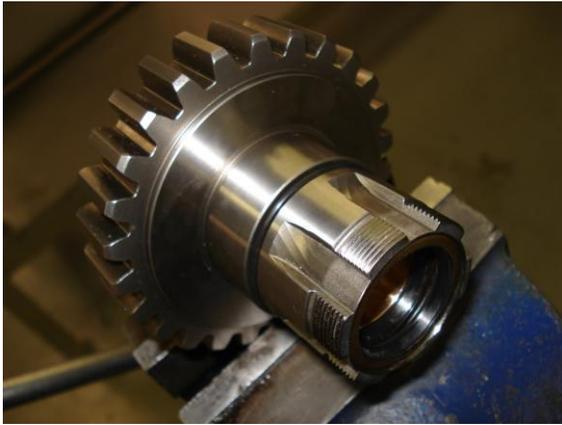
Here is a photo of a brand new Andrews gear that I also modified to accept both 2 end seals and new spacer with an O rings.

Note: that Andrews gear(late model) is now using an O ring seal on the shoulder of their gear, plus my spacer and includes one O ring on that run not far from their O ring, between end of spline and their O ring.

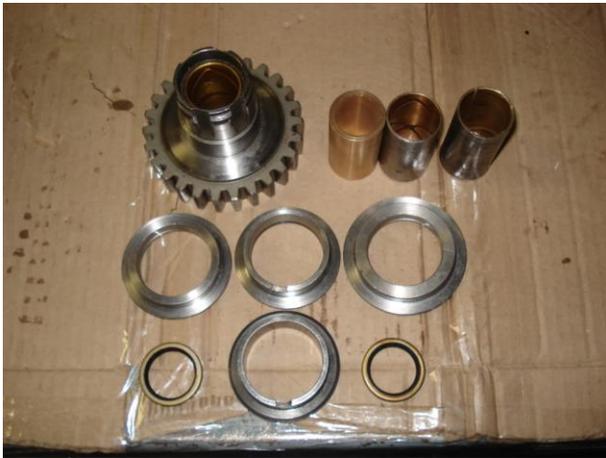
I forgot to mention that there is at least 5 type of spacers needed to do that kind of modifications, depending of the year of you transmission, there is two that is not shown in the picture, so 5 different types of spacers in all, but they all have the same inside diameter.
